FAA Approved
Airplane Flight Manual Supplement
For
Cirrus Design Corporation Model SR20/SR22
and SR22 when modified per STC SA10588SC
(Tornado Alley turbo-normalizer)
with
Avidyne DFC90 Digital Flight Control System p/n 700-00170-000

Page 1 of 44
P/N 600-00249-000
Rev 03

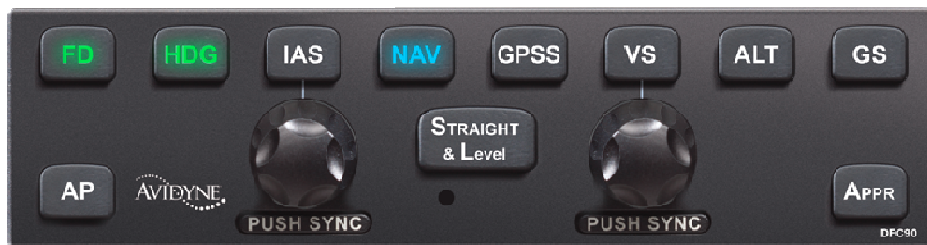
Figure 1 depicts the Avidyne 700-00170-000 DFC90 Autopilot Control Panel.

Figure 1 – DFC90 Autopilot Control Panel

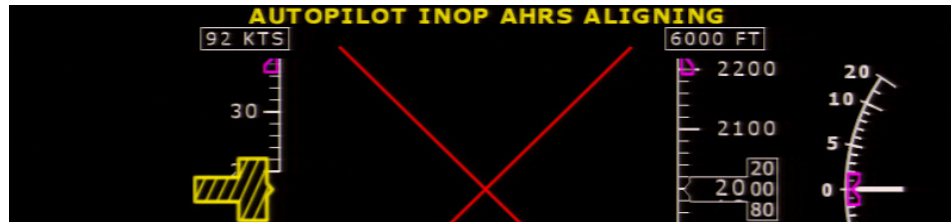
PFD Autopilot Annunciator

Autopilot failures that prevent any operation are annunciated across the center of the PFD mode annunciator strip in amber (yellow) as shown in the example immediately below.

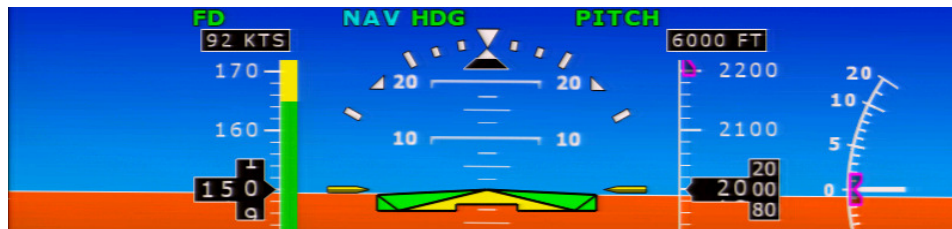
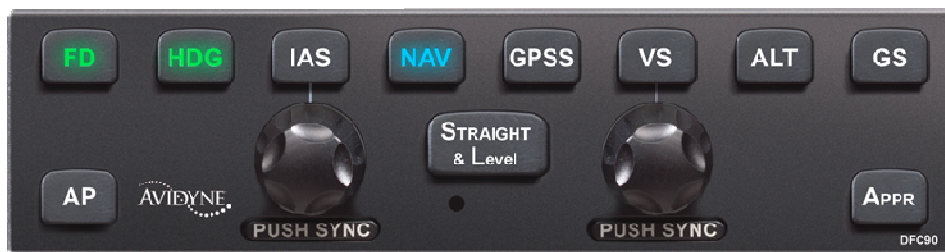
The DFC90 autopilot has been designed to always have both a lateral and vertical mode engaged. If a specific lateral mode has not been selected by the pilot, then the system defaults to Roll Hold mode. If a specific vertical mode has not been selected by the pilot, then the system defaults to Pitch Hold mode.
