Airplane Flight Manual Supplement
for the
Aircraft Make/Model:

Cirrus SR20/SR22

Avidyne Vantage12 Displays
p/n 700-00212-0XX Primary Flight Display and
p/n 700-00212-1XX Multi-Function Display

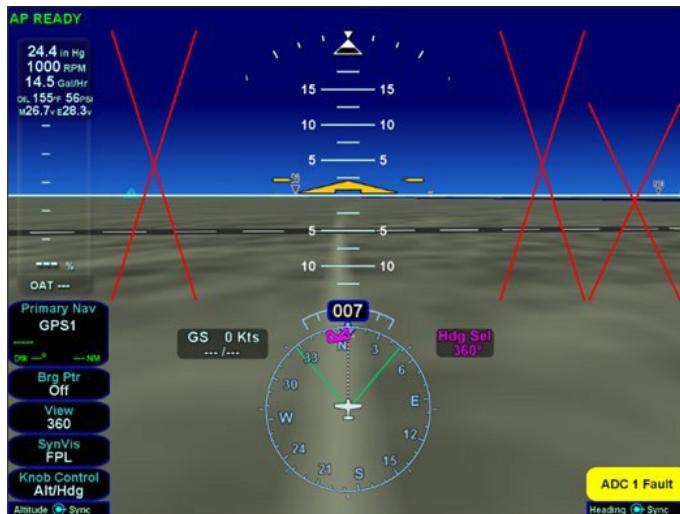
NOTE

To verify loss of dual ADC, refer to MFD SYS Alerts tab.

Figure 1 Loss of Dual ADC

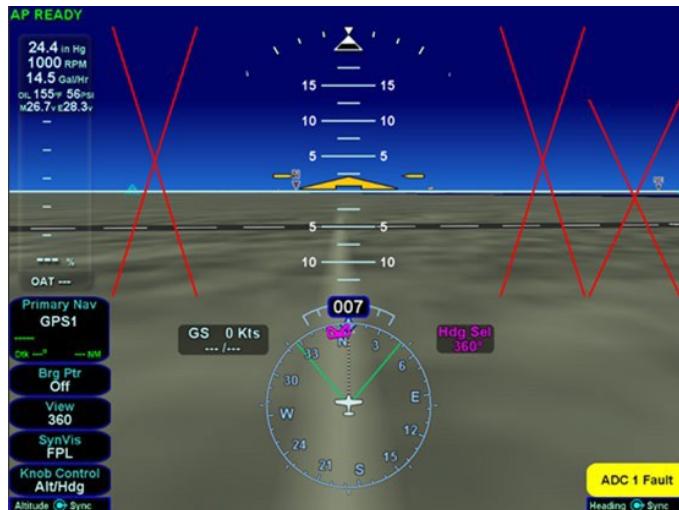
A pop-up caution message will display the following:
ADC 1 Fault

Figure 2 Loss of Single ADC

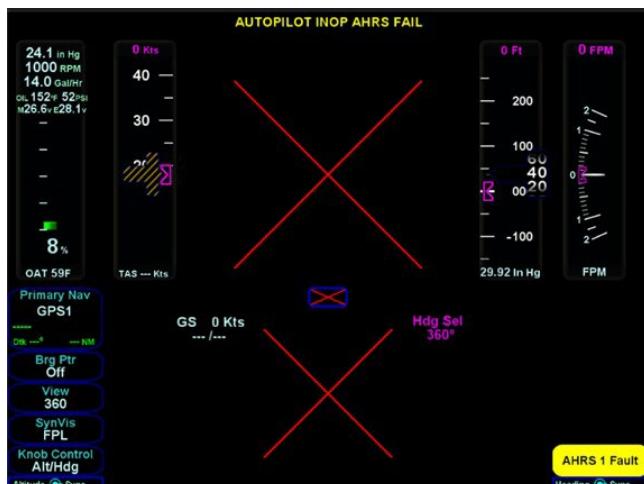
The following pop-up caution messages will be displayed based on chronology until the presently displayed message is acknowledged:

AHRS 1 Fault **AHRS 2 Fault**

The active map will be replaced with a black screen containing red X's

Figure 3 Loss of Dual AHRS

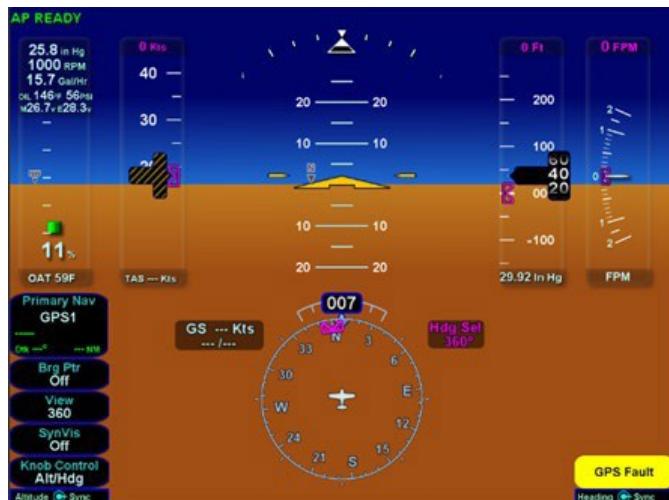
If both GPS sources are lost, the FMS will enter dead reckoning mode for 5 minutes, after that all FMS functions are lost and the ownship is removed from map depictions. Synthetic vision depiction on the Display(s) will revert to standard blue over brown attitude display.

The following pop-up caution message will be displayed:
GPS Fault

Figure 4 Loss of Dual GPS

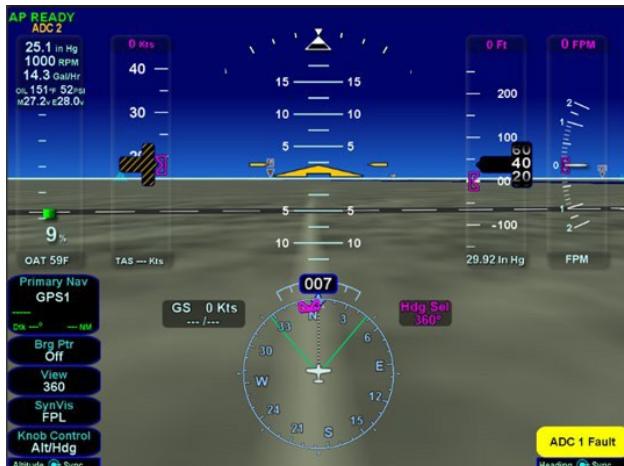
A pop-up caution message will display one of the following:
ADC 1 Fault - or - **ADC 2 Fault**

The display associated with the failed ADC will have an amber font message at the top left of the screen indicating usage of either **ADC 1** - or - **ADC 2**.

Figure 5 Loss of Single ADC

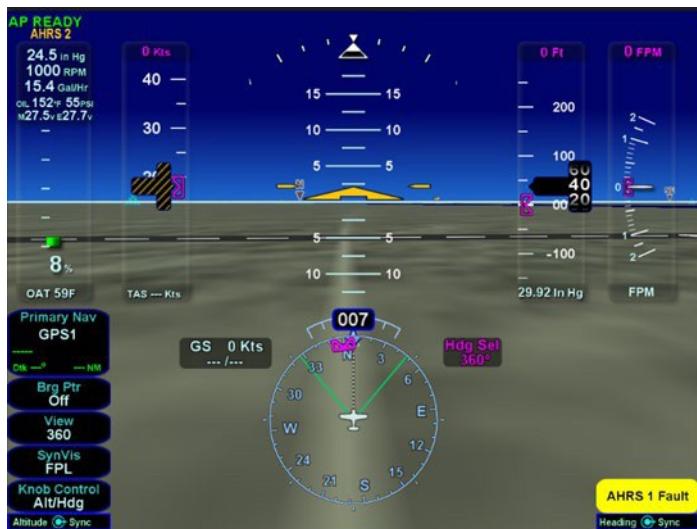
A pop-up caution message will display one of the following:
AHRS 1 Fault - or - **AHRS 2 Fault**

The display that houses the failed AHRS will have an amber font message at the top left of the screen indicating usage of either **AHRS 1** - or - **AHRS 2**.

Figure 6 Loss of Single AHRS

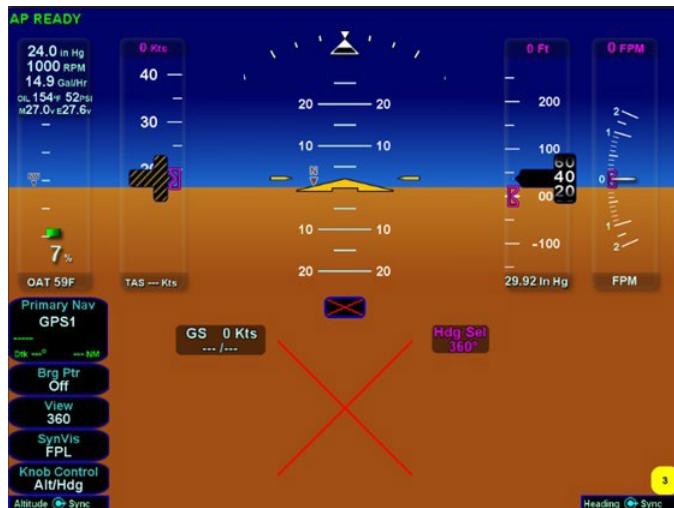
A pop-up caution message will display the following:
Mag 1 Fault

Figure 7 Loss of Single Magnetometer

A failure of the magnetometer in a single magnetometer installation results in both AHRSs being in a fault condition. The Vantage system will therefore not revert to the other AHRS. Heading and HSI on the PFD will be unavailable.

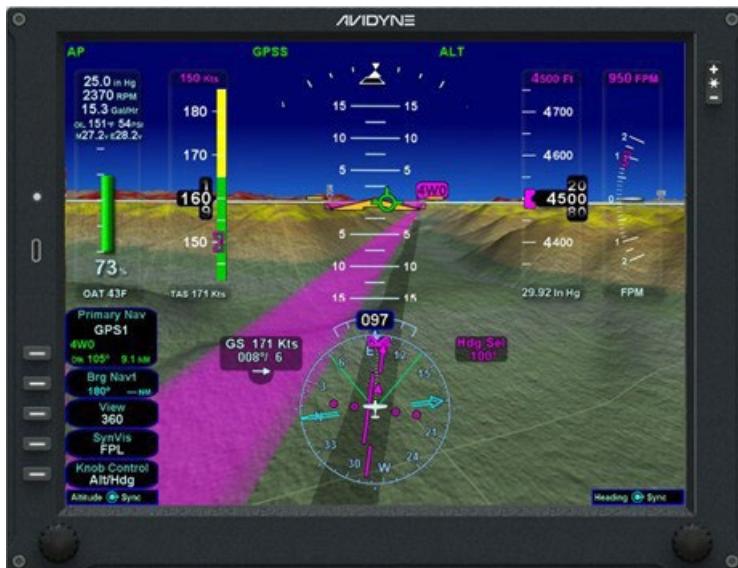
The PFD is a 12.1" unit that displays primary flight information to the pilot. The PFD receives data from a variety of sources including ARS, ADC, GPS (SBAS) receiver, VHF Nav/Com transceiver, and processing to accomplish control, display, navigation, and input/output to other avionics systems. The system is also integrated with an Avidyne DFC90 Autopilot, an audio panel receiver, and a transponder.

Figure 8 depicts the Avidyne Vantage12 Series 700-00212-010 Primary Flight Display in a normal operation full PFD.

Figure 8 - Avidyne Vantage12 700-00212-010 Primary Flight Display

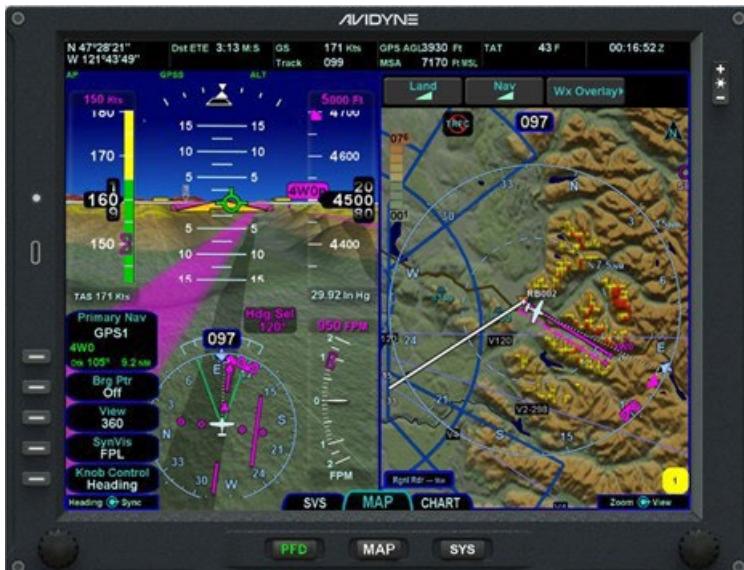
Figure 9 MFD in PFD Reversionary Mode

The **PFD** Button on the MFD displays the PFD screen (SVS Tab). Pressing the **MAP** Tab displays the PFD on the left half of the unit and the electronic map on the right. Pressing the **CHART** Tab displays the electronic chart to the right of the split-screen PFD.

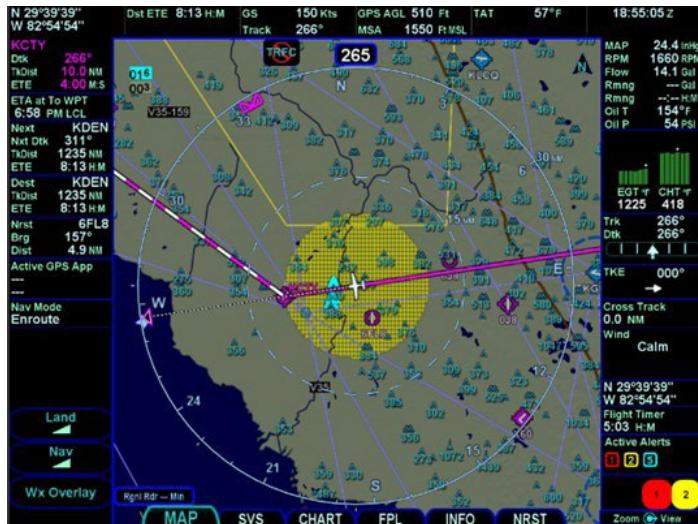
Figure 10 MFD MAP Tabs

On the MFD, the **MAP** Tab is the primary page and presents the pilot with aircraft position, flight plan and nearby weather, lightning and traffic. This data is overlaid on a moving map background of terrain, inland and coastal water bodies, airspace, airports, and navigational aids. Buttons and knobs on the MFD bezel allow the pilot to control the amount and presentation style of information on the moving map.

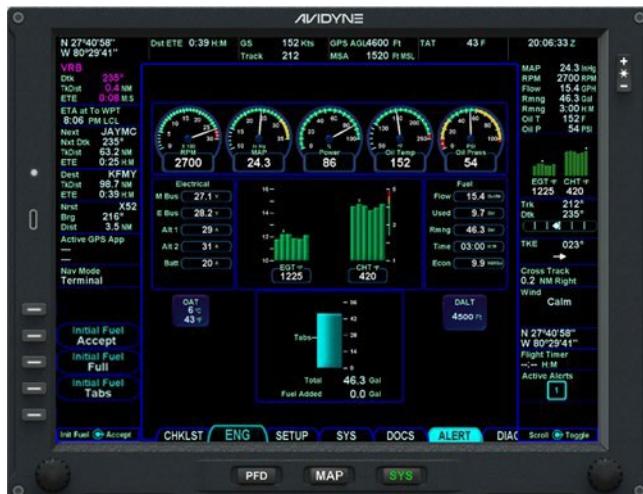
Figure 11 depicts the Avidyne Vantage12 700-00212-110 Multi-Function Display.

Figure 11 Avidyne Vantage12 700-00212-110 Multi-Function Display
